U.S. Department
of Transportation
**Federal Aviation
Administration**

ADVISORY CIRCULAR

43-16A

AVIATION MAINTENANCE ALERTS

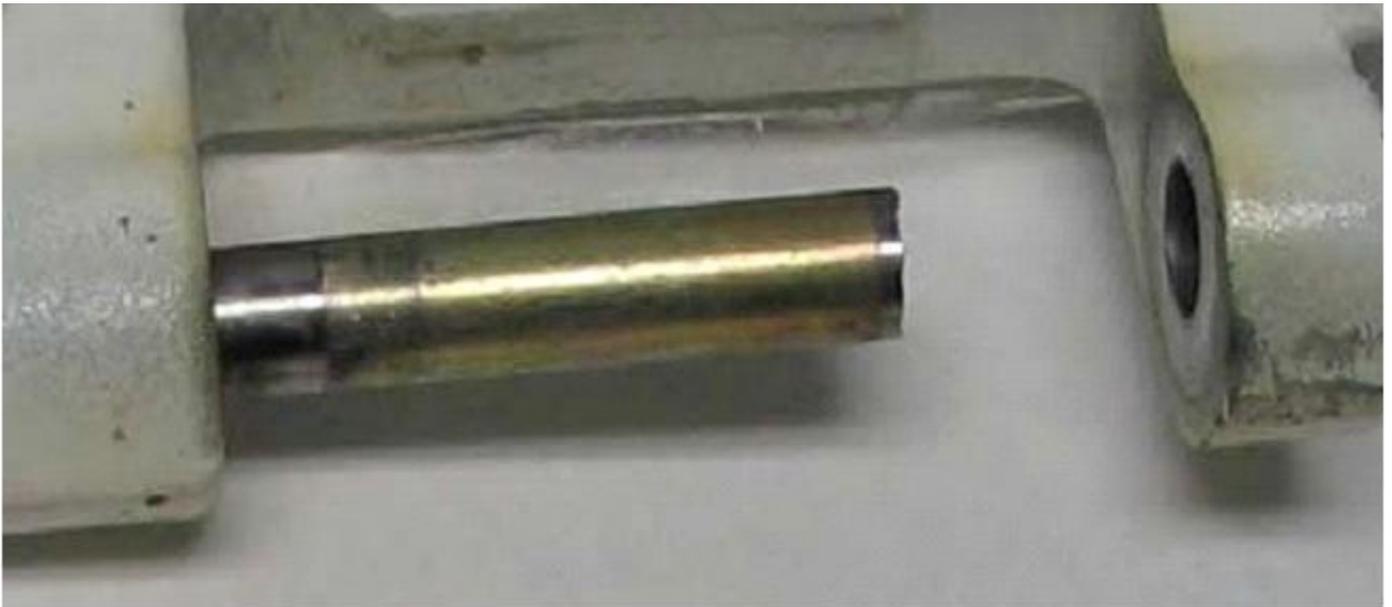
Figure 23. The gold color is removed from the bolt very near the fracture zone.

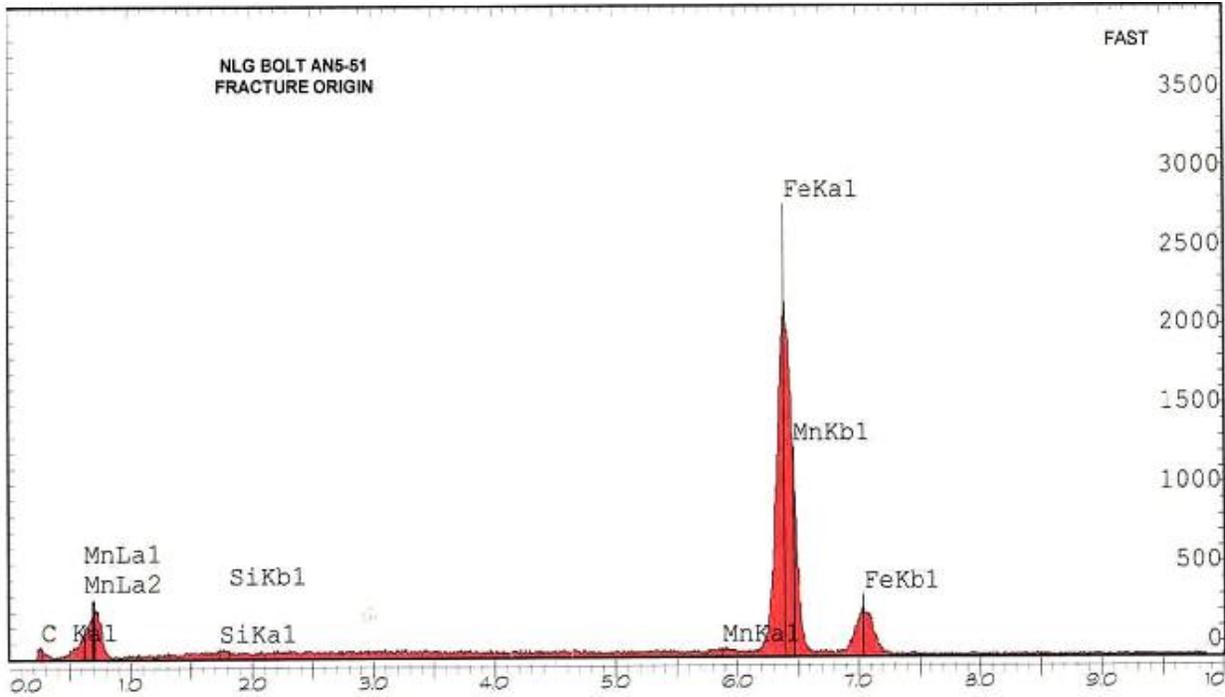
The bolt was found to be made of a non-corrosion resistant steel in accordance with the AN5-51 bolt specification, Figure 24. The outer surface was plated with cadmium and a chromate conversion coating, Figure 25.

Figure 24. The base metal of the bolt is low alloy carbon steel.

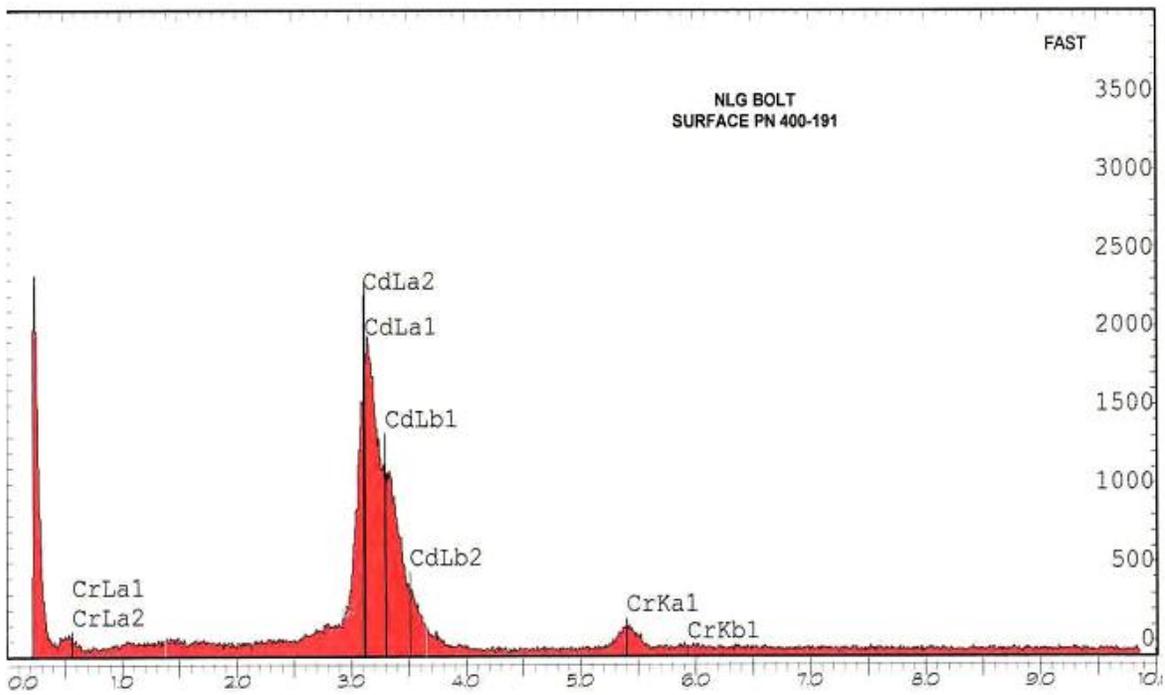
Figure 25. The bolt outer surface is plated with cadmium and a chromate conversion coating.
